# OPTICAL FIBER STRAIN MEASUREMENTS AND NUMERICAL MODELING OF LOAD TESTS ON GROUTED ANCHORS

Jef Smet<sup>1</sup>, Noël Huybrechts<sup>1,2</sup>, Gust Van Lysebetten<sup>2</sup>, Jan Verstraelen<sup>3</sup>, and Stijn François<sup>1</sup>

## ABSTRACT

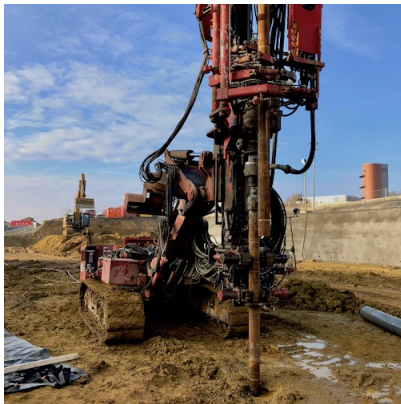
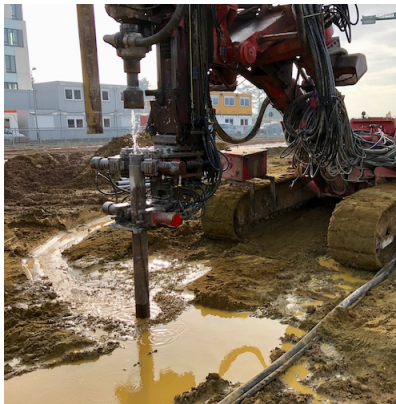
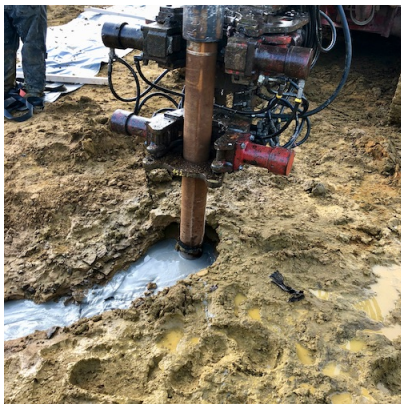
**Fig. 2.** Overview of the drilling process, including (a) cross-section of the grout anchor, (b) boring of the drilling rods into the ground, (c) installation of a second drill element with return boring liquid flowing out of the borehole, (d) flushing with water as the final depth is reached, (e) injection of grout until it flows out of the borehole, (f) decoupling of the drilling table from the rods for the installation of the anchor strands, and (g) installation of the optical fiber together with the steel strands.

The test anchor consists of 9 steel strands of ST1660/1860 steel with a cross section of  $150 \text{ mm}^2$  per strand (figure 2a). The anchor is grouted in a vertical borehole with a total anchor length of 15 m, consisting of 5 m tendon free length and 7 m tendon bond length. As the test anchor had a temporary and experimental purpose, no corrosion protection has been provided. In the tendon free length, the strands are surrounded by a plastic tube to prevent a rigid connection between steel and grout. Along each bundle of strands, 3 grout injection tubes are present (figure 2a). The grout injection tubes are used to perform high pressure post-grouting through 4 holes with a spacing of 1 m. 2 tubes are actually used during post-grouting, whereas the third tube is used as a spare.

In a first step, the drilling machine is positioned at the drilling location with the rig raised in a vertical position. The drilling rods are equipped with the drill bit (figure 2b) and driven into the ground using water as a drilling fluid (figure 2c). Once the final depth is reached, the borehole is flushed with water to remove loosened soil particles (figure 2d). Next, grout with a water/cement ratio of 0.5 is pumped through the drilling rods into the borehole. This allows the borehole to fill in a gravitational way (figure 2e). Once the borehole is completely filled, the drilling rods are disconnected from the drilling machine. A funnel is placed on top of the drilling rods to facilitate the lowering of the anchor strands in the borehole (figure 2f). At this stage, the optical fiber is installed (figure 2g). The optical fiber has been glued on a glass fiber-reinforced plastic carrier tube, which is gradually attached to the bundle of steel strands during lowering. This fiber-carrier system has been developed to provide a compromise between protection of the optic fiber and the reliability and accuracy of the deformation measurements. After the installation of the anchor strands and the optical fiber, all drilling rods are removed while additional grout is injected under gravitational pressure.
